COLUMBIA

ACCIDENT INVESTIGATION BOARD

REPORT VOLUME V
APPENDICES G.1 - G.9
OCTOBER 2003

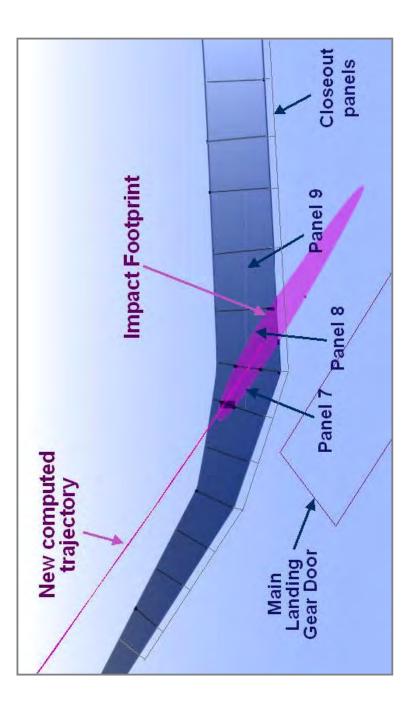
Figure 2

Projection of Debris Trajectory onto Left Wing

approximately RCC panel 8, with the most likely foam impact predicted Centerline of one-foot diameter trajectory "pipe" intersects the wing at along panels 7 and 8

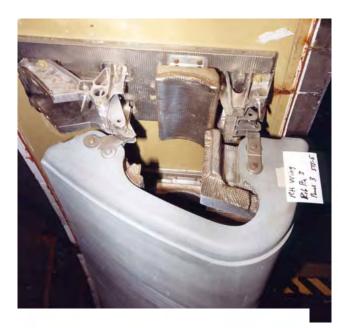
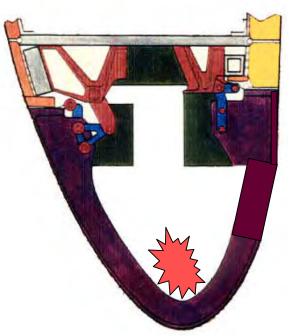
Figure 10

Hot gases enter the chunnel

- Flow behind RCC
- Outward through Chunnel

Jet of hot gases coming down the chunnel

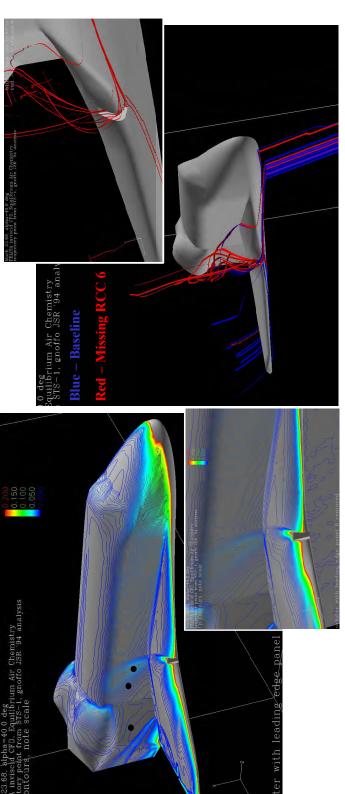
Figure 12

Orbiter with RCC Panel 6 Removed – Mach 23.8

- Produces negative roll and yaw moments w/small magnitude
- Streamlines for damaged vehicle track inboard of baseline
- Resultant shock raises pressure in proximity to temp measurements

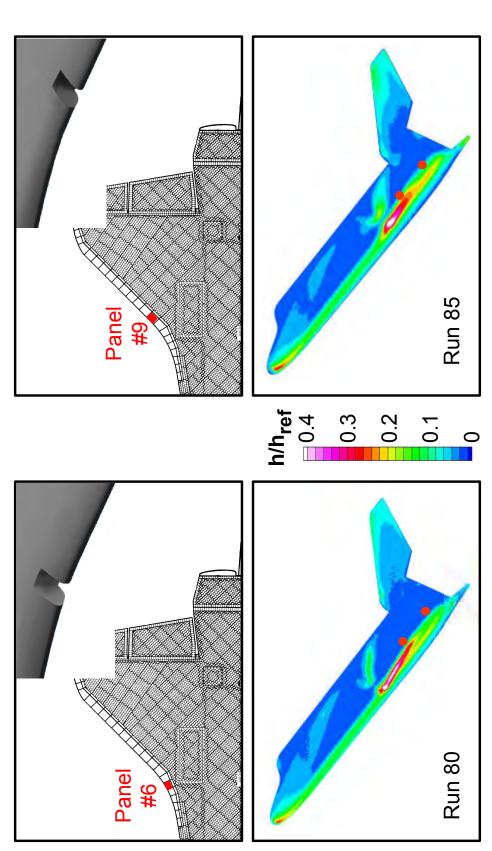
Effect of RCC Panel Cutout Position on Orbiter Fuselage Nondimensional Heating, Wind Tunnel Testing of Orbiter OML Deltas Panel 6 vs. Panel 9

Side fuselage heating 2 to 10 times nominal configuration heating.

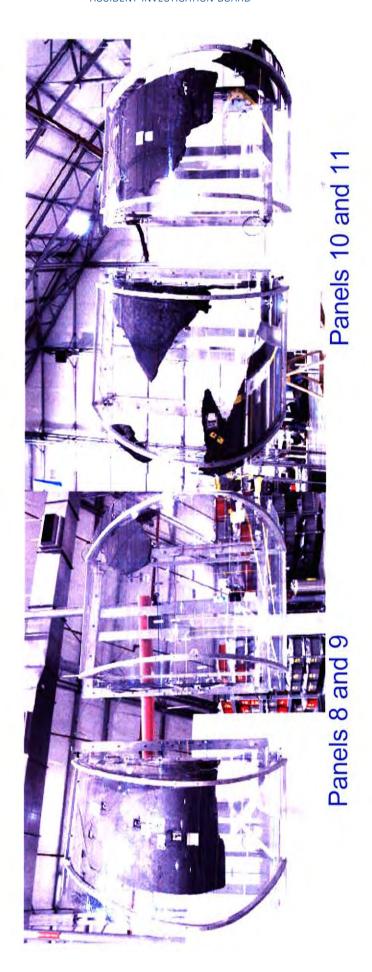
Figure 20b

Deposits and Erosion Indicate an Outboard Flow Substantially Less RCC Material

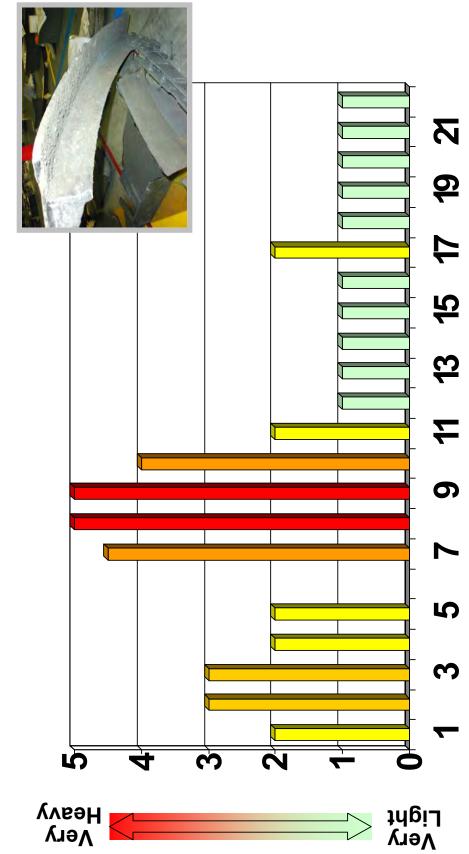
Relative Metallic Deposition on Left Wing Materials

Distribution of metallic deposition volume was centered around panels 8 & 9
