COLUMBIA

ACCIDENT INVESTIGATION BOARD

REPORT VOLUME V
APPENDICES G.1 - G.9
OCTOBER 2003

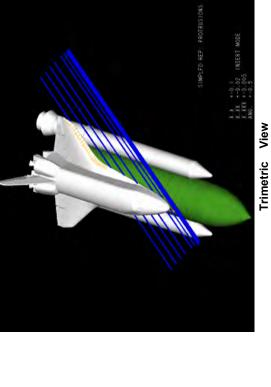
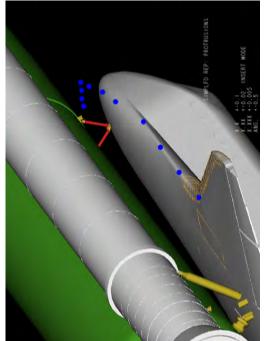
Ascent Debris Trajectory

A large piece of foam (debris) from the bipod area of the external tank (ET) is evident in the film of the STS-107 during launch. The trajectory of the debris, which is shown in Figure 1, indicates that the ET foam debris struck the wing leading edge 82 seconds after launch. Based on this trajectory, the likeliest area of impact was on RCC Panel 6, or slightly downstream. See Figure 2. As shown in Figure 3, RCC Panels 1 through 4 are located on the glove, which has a sweep angle of 81°. RCC Panels 5 through 7 are located on the intermediate spar, a. k. a., the transition spar. RCC Panels 8 through 19 are located on the wing spar, which is swept 45°,

Solid cylindrical protrusions were created through the debris locations in each view

approximately RCC panel 8, with the most likely foam impact predicted Centerline of one-foot diameter trajectory "pipe" intersects the wing at along panels 7 and 8

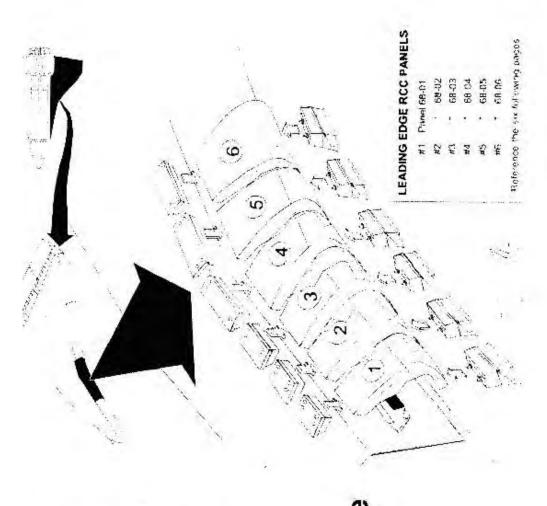
Figure 4

The wing-leading-edge subsystem (LESS) is shown in the sketch of Figure 4. The impact of the debris with a leading-edge RCC panel could have removed (all or part of) a T-seal or produced a hole or a crack in the RCC panel itself. In an attempt to further define the location and the extent of the debris-induced damage, NASA personnel and their contractors have been using computational fluid dynamic (CFD) codes. Additional work is needed to complete and to validate the analysis efforts, e. g., use the direct simulation Monte Carlo (DSMC) computational tools to provide an independent validation of the flow field at these low-density gas conditions. The modeling of the internal flow through the chunnel, starting with a breech of the leadingedge TPS (using the location and the nature of the breech to define the boundary conditions for a few likely initial conditions), and proceeding into the wing is a very complex task that should be completed. Of special interest is matching the computed results to the observed times for (1) the burn through of the MADS wires behind the spars. (2) the burn through of the bundle of wires that ran along the wall of the main leftlanding-gear, and (3) the anomalous temperatures measured at various points inside the left main-landing-gear wheel well.

mounting hardware (LESS) comprised of RCC panels, T-Edge Subsystem Seals, Upper and · Wing Leading Lower Thermal Barriers, and associated

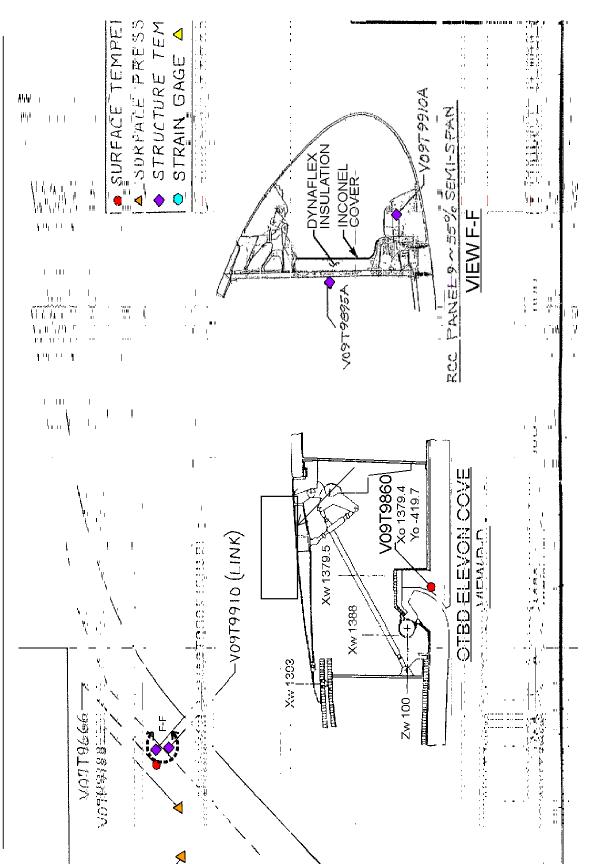
RCC Panel 9 Sensor Locations

As shown in Figure 5, three sensors were located in the vicinity of RCC Panel 9: two thermocouples and a strain gage. AT GMT 13:48:39, the strain gage on the left wing spar at RCC Panel 9 starts an off-nominal increase, as indicated in Appendix A. This is only 270 seconds after EI. At this point in time, the Orbiter is located about 1000 miles west of the California coast, flying at 23,000 feet/second at an altitude in excess of 270,000 feet. Refer to Table 1. Referring to Table 1 and to Figure 6, the temperature sensed by the thermocouple on the Spar 9 Clevis starts to increase by (approximately) GMT 13:49:00, which is less than 300 seconds after EI. According to Table 1, the temperature sensed by the thermocouple on the back of Spar 9 starts to increase very rapidly with time beginning at GMT 13:51:09. Refer now to Figure 7. Signal is lost from the thermocouple on the clevis at (approximately) 55 deg F, 490 seconds after EI. At approximately 522 seconds after EI, signal is lost from the thermocouple on the back face of the spar at a temperature exceeding 240 deg F.

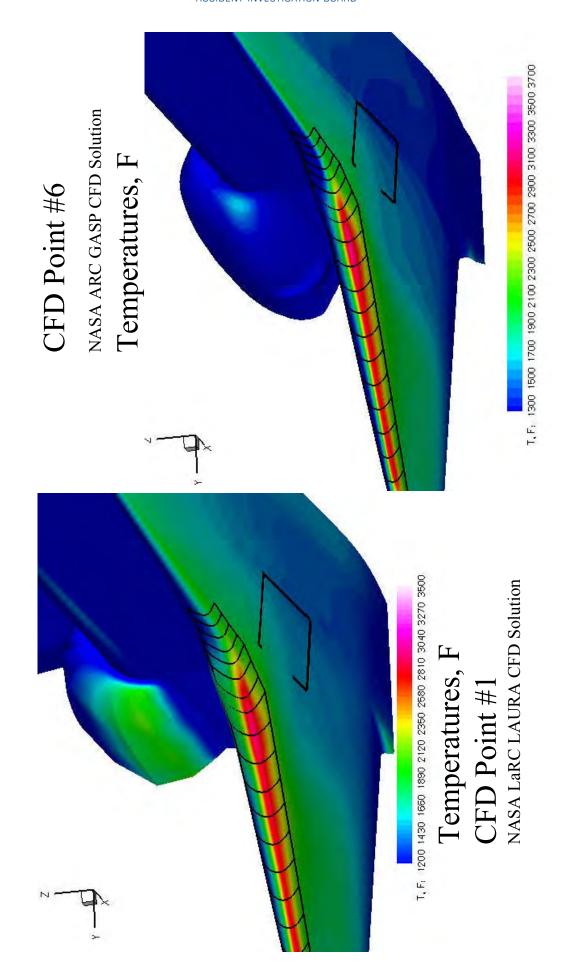
Convective heating rates in the interaction region of the wing leading edge have been computed for the Shuttle Orbiter. The computed heat-transfer rates that are presented in Figure 9 indicate that the interaction between bow shock wave and the wing-leading-edge shock wave causes the heating to the surface in the interaction to be approximately twice the undisturbed value and that RCC Panel 9 experiences the highest heating. Because the Orbiter is operating at an angle-of-attack of 40-degrees, the stagnation line is on the windward surface just below the apex of the leading edge. Thus, the highest convective heating to the wing-leading-edge region affects RCC Panel 9, on the lower surface, just below the leading edge. As noted in the previous paragraphs, under normal circumstances, these incident heating rates would be accommodated by radiation from the back surface of the RCC panel into the cavity and by conduction through the reinforced carbon/carbon shell, away from the stagnation line. However, as shown in the sketch of Figure 10, the hot gases flowing up the chunnel not only eliminate the ability to transfer energy away from the wing leading edge, but they produce a situation where energy is added to the RCC panel from the inside as well as from the outside. It doesn't take long before the material near the stagnation line (on the lower surface) fails, leaving relatively sharp RCC plates, exposed to the flow. Thus, the authors believe that a second breech of the thermal protection system has occurred. The authors believe that this one is most likely to be on the lower surface of RCC Panel $9 \pm$ one panel. The authors' belief that there are two breeches to the RCC panels along the wing-leading edge is based upon not only the sensor data, but upon the Kirtland photograph, which will be discussed as "critical data/event" #10. Gases quickly flow from the high pressure region in the shock layer near the stagnation line into the chunnel, causing the destruction of the lower surface of the panel. The authors believe that this is a significant change in the Orbiter Mold Line (OML). The changes in the OML of the wing leading edge modify the vortices that emanate from this region and that impinge on the leeward fuselage. Therefore, it is associated with the start of off-nominal temperature histories at the four sensors on the left OMS Pod, which are described in "critical data/event" #5.

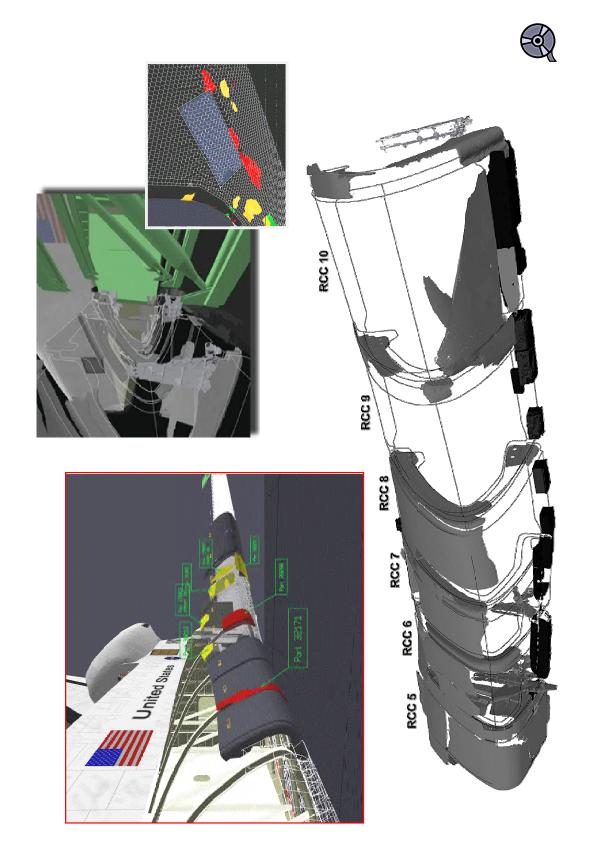
Figure 20c

- 2. Hot gases entering a breech near RCC Panel 6 have several negative effects. First, hot gases flow down the chunnel, causing the MADS sensors near spar 9 to have anomalous responses early in the entry. The slag and other melting metallic components are splattered onto the surfaces behind RCC Panels 7 through 10. See Figure 21. Second, the incoming plume impinges on the spar, eventually burning a hole. Third, the hot gases in the chunnel reduced the heat rejection capability of the RCC panels downstream (outboard) of RCC Panel 6. Since these RCC panels are in the region where the baseline shock/shock interaction pattern is most severe, a second breech in the TPS occurs near RCC Panel 9 ± one panel. Soon other RCC panels in the vicinity experience significant ablation. See Figure 20(c).

Virtual 3-D Reconstruction of Debris

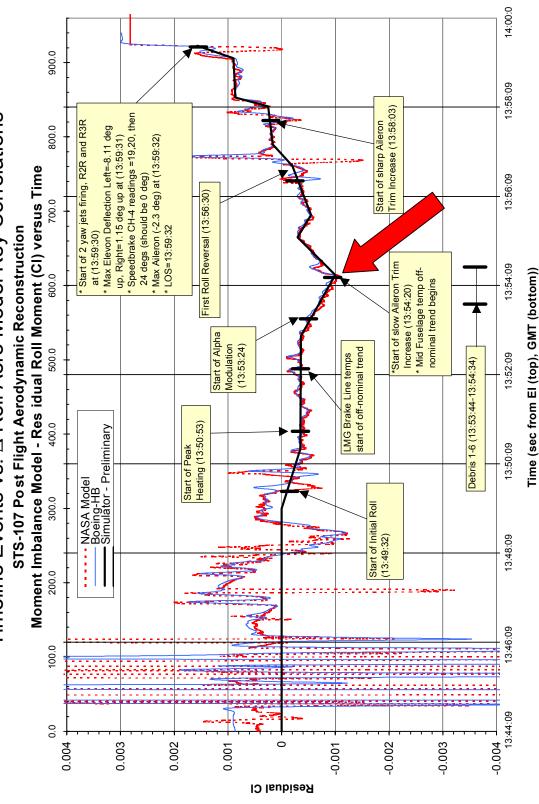
Figure 30

The delta rolling moment history is presented in Figure 30. The strong oscillatory variations of the delta rolling moments that occur before GMT 13:50:00 were attributed to experimental uncertainty from the outset, as noted by Labbe et al. [Ref. 3]. From GMT 13:50:00 through GMT 13:53:00, the delta rolling moment was relatively constant and negative. The magnitude is within the experimental uncertainty. Furthermore, additional review of these data indicated that there had been flight-to-flight variations of similar magnitude from previous flights. Winds were offered as another factor that could have affected the data in this time frame. Because of these three factors, the authors have assumed that none of the delta rolling moment data for times before GMT 13:53:00 are definitive.

From GMT 13:53:00 to GMT 13:54:00, the delta rolling moments are negative (left-wing down) and becoming more negative with time. See Figure 30. In the same time frame are the first five debris events. Recall that, for the flow field that was computed for the Orbiter with RCC Panel 6 missing, there were negative rolling moments of small magnitude. See Figure 12.

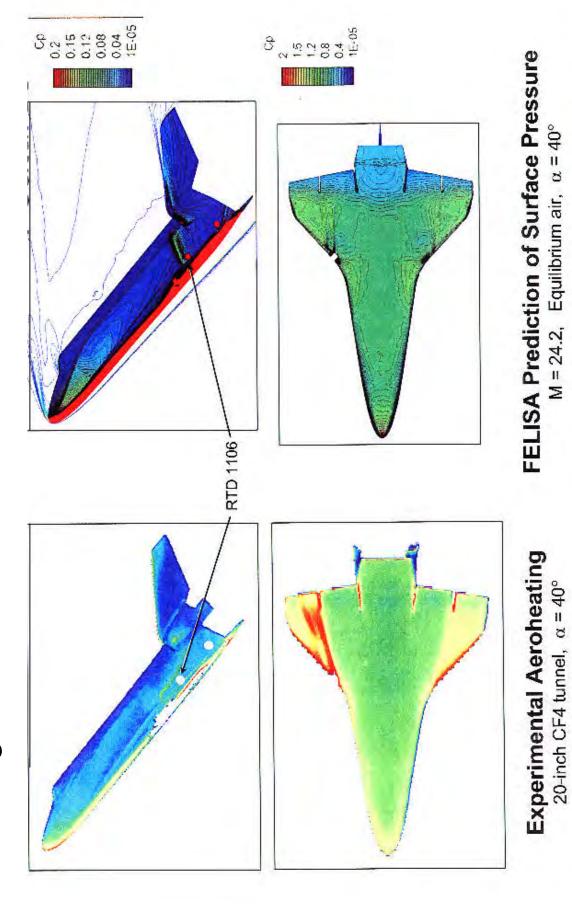
CA-000112

Missing RCC Panel 9 – Surface Flow Features
